UM-3741-98

1998 FORD ESCORT

In-depth Vehicle Occupant Report

The University
of Michigan
Transportation
Research Institute

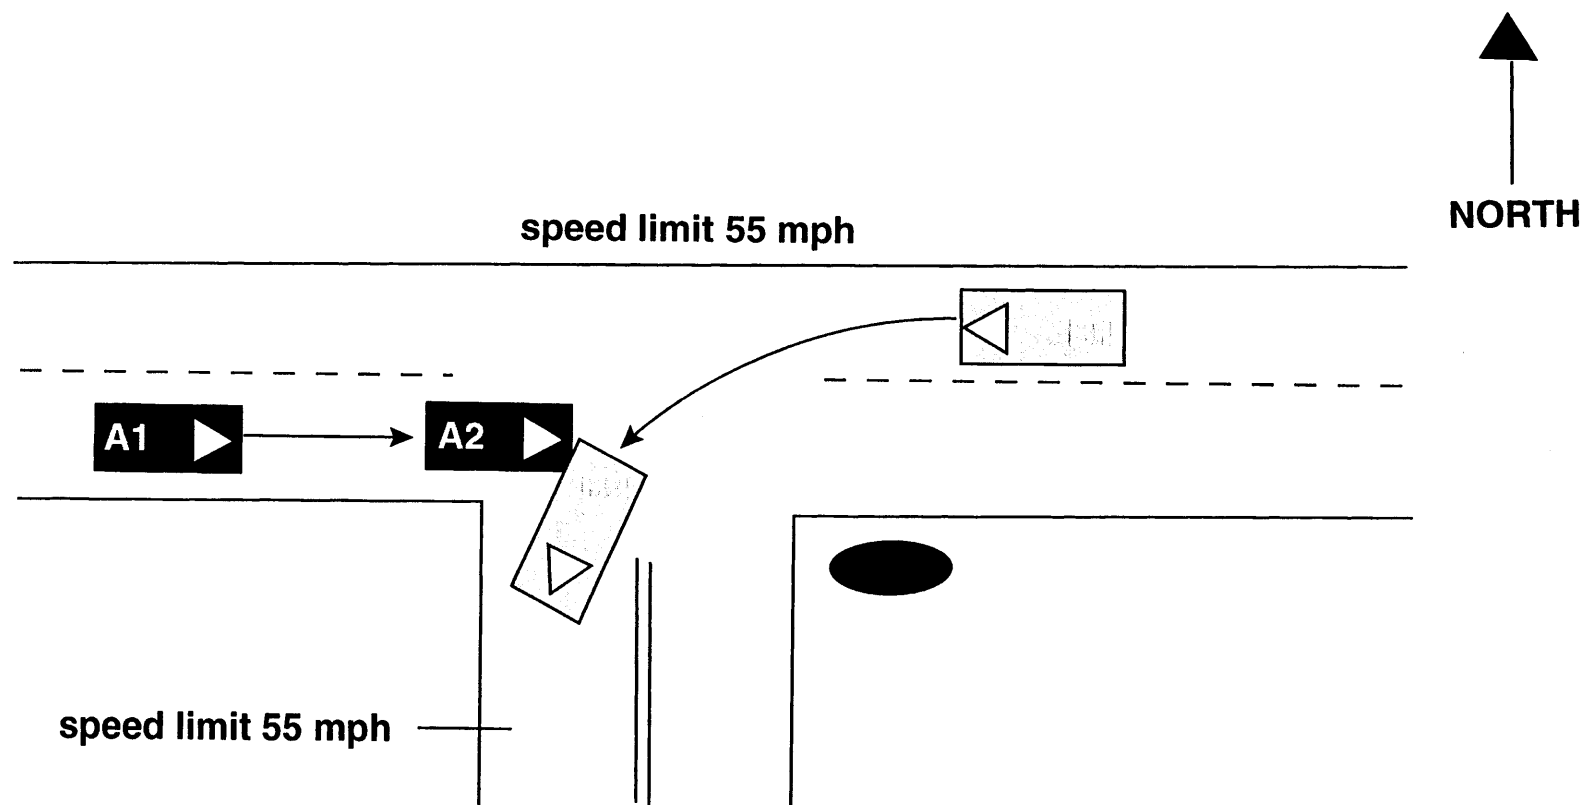
(Slide 1, 2) At the time, the weather was clear, the roads were dry, and it was daylight. Case vehicle (A) was traveling east at a driver-estimated speed of 89 kph (55 mph) in the eastbound lane of a 2-lane asphalt road in a rural area. Vehicle (B) was traveling west at an unknown speed in the westbound lane of the 2-lane roadway, and the sun reportedly was very bright, limiting visibility. As case vehicle (A) approached a 3-leg intersection, the driver of vehicle (B) began making a left turn across the eastbound lane, so as to travel south. The driver of case vehicle (A) reportedly applied the brakes, but was unable to avoid striking the right rear of vehicle (B) with its front.

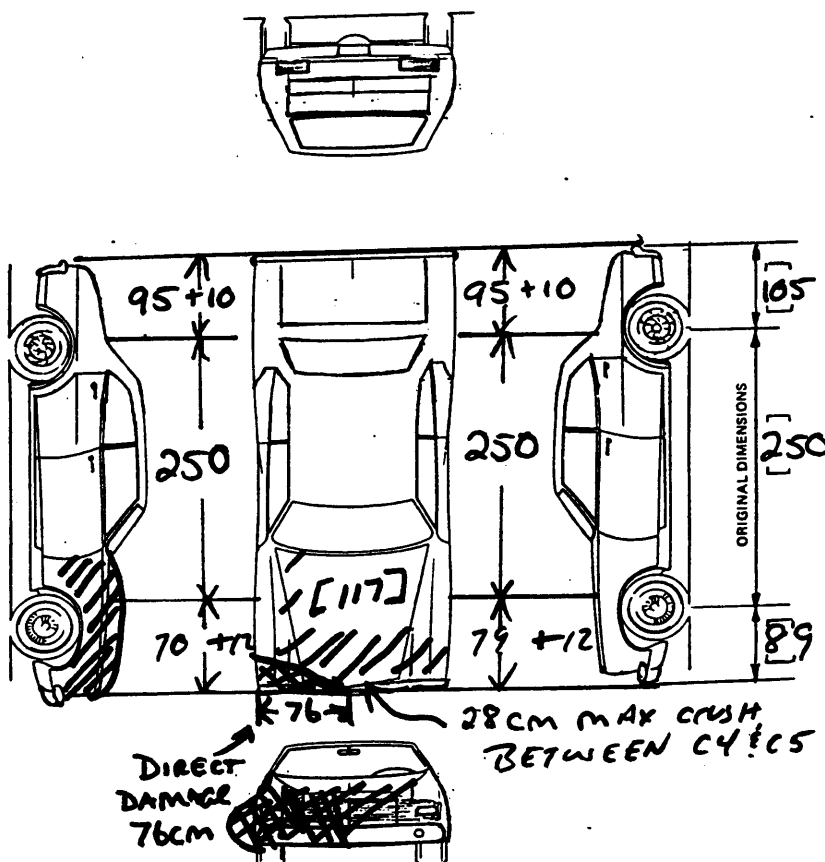
VEHICLE DAMAGE

Direct Damage Length (DDL) 076 cm

Specific Impact No.	Location of Direct Damage	Location of Field L
1	76cm - BEGINS AT BUMPER CORNER RIGHT-FRONT BUMPER TO BUMPER CORNER	CORNER

Specific Impact Number	Plane of Impact C-Measur.	Direct Damage		Field L	C ₁	C ₂	C ₃	C ₄	C ₅	C ₆	±D
1	1	76	30	136	10	6	10.5	19	19	19	+37
			2		12	4	0	0	4	12	
			28		0	2	10.5	19	15	7	
1	1	076	028	136	000	002	011	019	015	007	+037
13	14	15 16 17	18 19 20	21 22 23	24 25 26	27 28 29	30 31 32	33 34 35	36 37 38	39 40 41	42 43 44 45
2

(Slide 8) Damage to the front of case vehicle (A) was minor with a maximum crush of 28 cm to the center-front bumper. (Slide 9) The direct damage began at the right-front bumper corner and extended 76 cm across the front, resulting in 51 percent front-end overlap and 51 percent vehicle overlap. (Slide 10) The front bumper was crushed, the

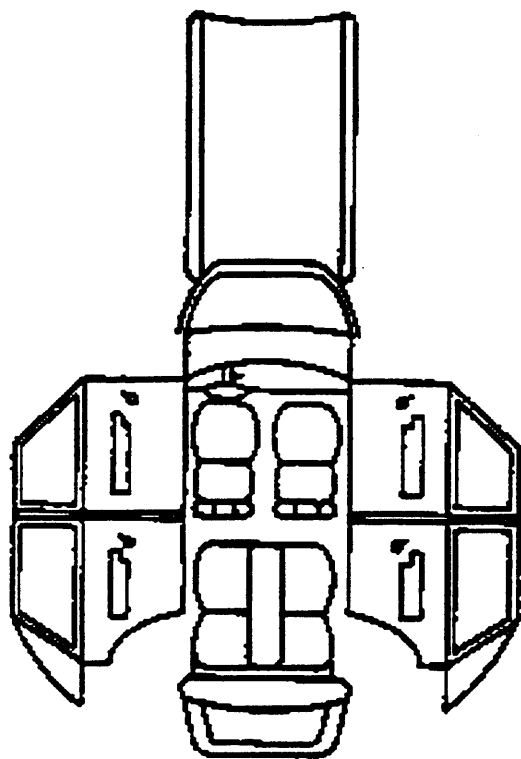
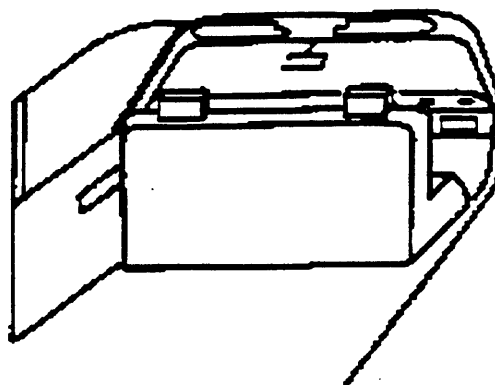
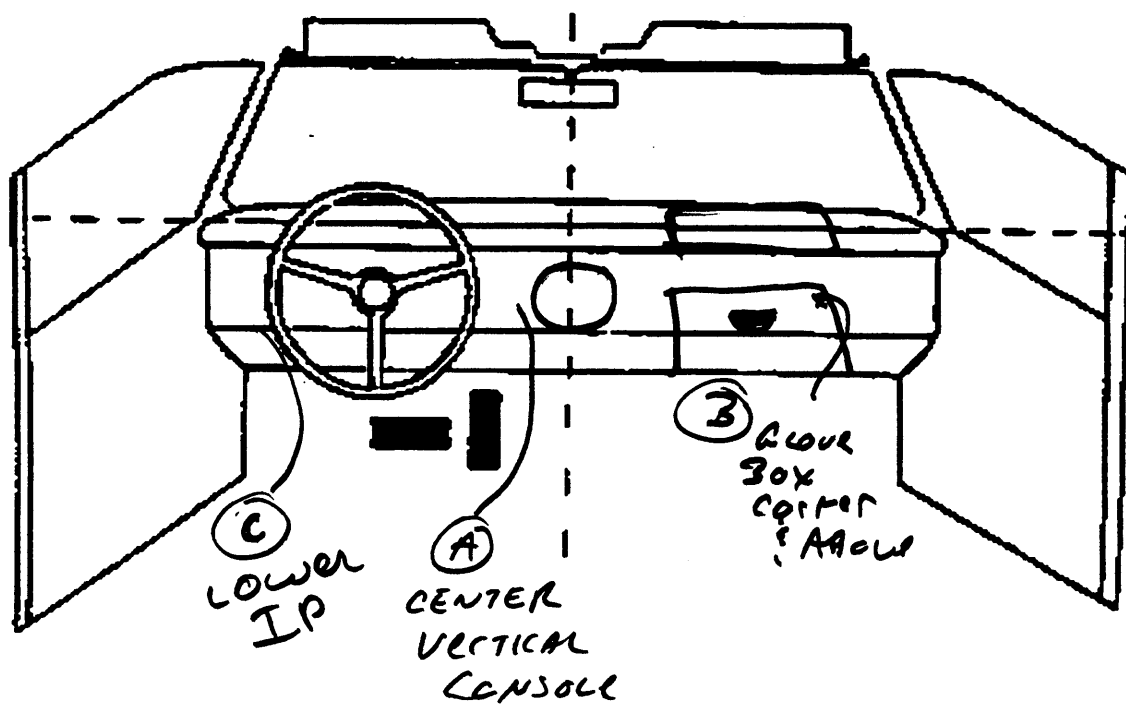
VEHICLE OCCUPANT CONTACT DIAGRAM

DR BELT: UP-POSITION
ON B-PILLAR

RF BELT: LOW-POSITION
ON B-PILLAR

(Slide 23, 24) The 35-year-old female driver was wearing the available 3-point belt, and the steering-wheel airbag deployed during this frontal impact. She reportedly had the seat in the forward-most seat-track position, and the tilt steering wheel in the up position. The shoulder-belt anchor adjuster was set to the up position on the B-pillar. During the frontal impact, she moved forward into the belt and deploying airbag. She sustained a contusion to her left shoulder from loading by the shoulder portion of the 3-

(Slide 27) The 38-year-old male, right-front passenger was wearing the 3-point belt. His seat was reportedly in the rear-most seat-track position and the shoulder-belt adjuster was set to the low position on the B-pillar. (Slide 28) A passenger frontal-impact airbag was supplied in this occupant area, but it did not deploy. (Slide 29) Although there was a scuff mark on the glove compartment area, no injury was noted. The passenger did not sustain any injuries.
